Subject: Substandard Meter Pan Condition Within the Complex

Safety Notice

Arrow Hart Murray Ring Type Multi-Stack Meter Pans

Date: April 8th, 2016

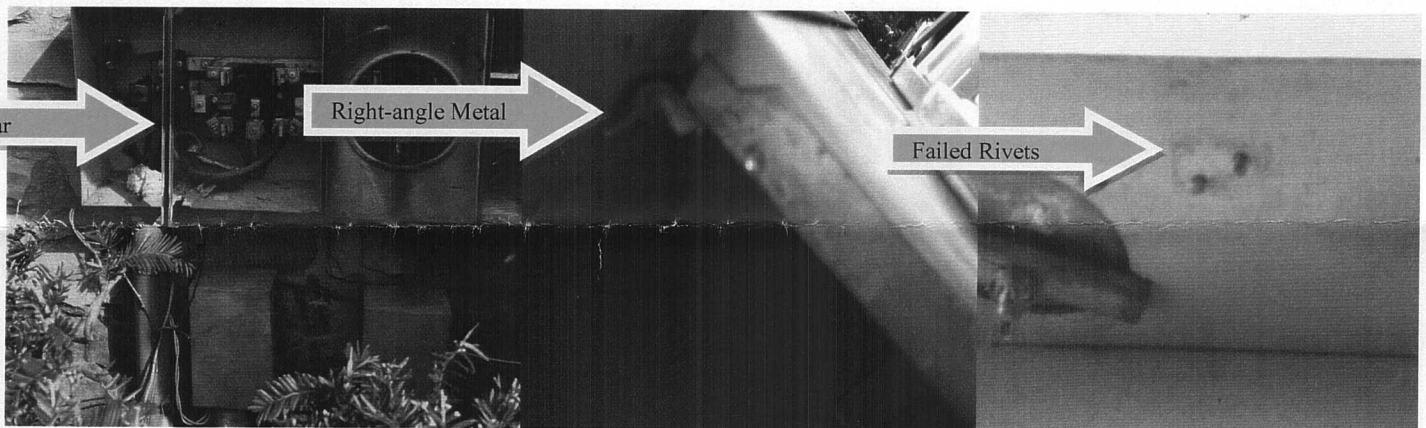
- Upon further investigation, Meter Services determined the cause was manufacture defective equipment. This was due to age of equipment and inferior parts/manufacture process. These pans are no longer manufactured as of 1992, this does not pertain to new Murray Multi-Stack meter pans.

- Arrows indicate point of failure. The spacer bar has a right-angle piece of metal that gets secured to the top of the meter pan with rivets. This right-angle piece of metal became detached from the spacer bar, the bar then fell and made contact with line-side lug resulting in a flash inside the meter pan which cannot be seen externally.

- If a turn-on order is generated, customer will need to replace meter pan prior to completion of cut-on.
**** DO NOT CUT-ON ****
- If a turn-off order is generated, electric service needs to be disconnected. ****DO NOT PERFORM CUT-OFF AT THE METER WHILE ENERGIZED****
- Electric Design is going to be issuing letters to customers at this location. Should you come across other locations with this type of meter pan, please notify Electric Design supervisor.
