Subject: Substandard Meter Pan Condition Within the Complex

Safety Notice

Arrow Hart Murray Ring Type Multi-Stack Meter Pans

Date: April 8th, 2016

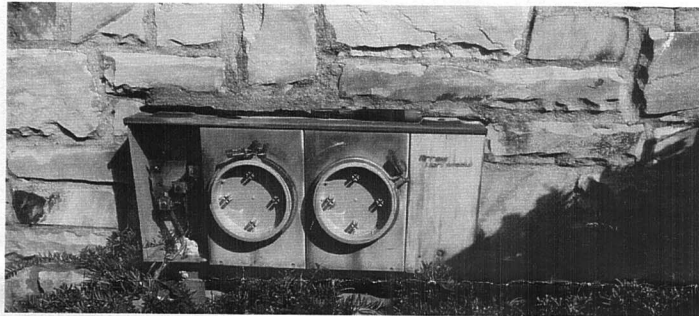
- At Strathmore Ridge Complex, off Smith Rd in Ridge, a Technician C attempted to remove the snap-lock from a meter pan at a vacant location to cut-on service, the employee noticed a spark that had emanated from the bottom of the meter pan. The employee ceased operation of cut-on order until customer's electrician takes corrective action to make meter pan safe.

- Upon further investigation, Meter Services determined the cause was manufacture defective equipment. This was due to age of equipment and inferior parts/manufacture process. These pans are no longer manufactured as of 1992, this does not pertain to new Murray Multi-Stack meter pans.

- Arrows indicate point of failure. The spacer bar has a right-angle piece of metal that gets secured to the top of the meter pan with rivets. This right-angle piece of metal became detached from the spacer bar, the bar then fell and made contact with line-side lug resulting in a flash inside the meter pan which cannot be seen externally.

- If a turn-on order is generated, customer will need to replace meter pan prior to completion of cut-on.
**** DO NOT CUT-ON ****
- If a turn-off order is generated, electric service needs to be disconnected. ****DO NOT PERFORM CUT-OFF AT THE METER WHILE ENERGIZED****
- Electric Design is going to be issuing letters to customers at this location. Should you come across other locations with this type of meter pan, please notify Electric Design supervisor.
